Assessment of the USAF Aircraft Accident  
Investigation Board (AIB) Report on the F-22A Mishap  
of November 16, 2010

**UNITED STATES AIR FORCE**  
**AIRCRAFT ACCIDENT INVESTIGATION**  
**BOARD REPORT**

**F-22A, T/N 06-4125**

**DATE OF ACCIDENT: 16 NOVEMBER 2010**

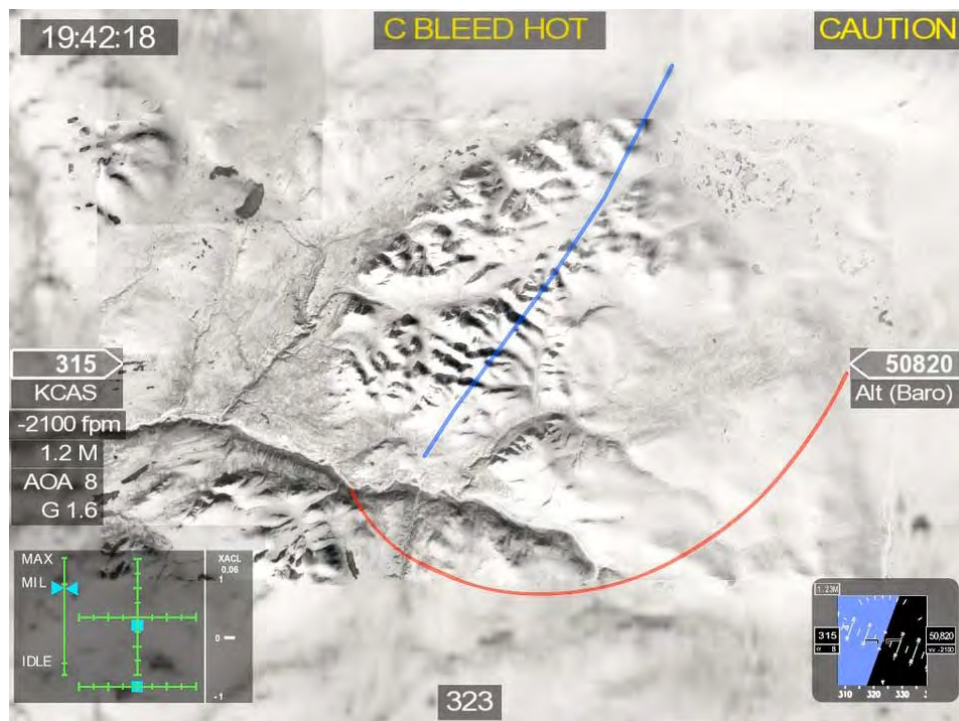
**Figure 1 19:42:18L -- Relative position between MFL (blue) and MP (red) at the assertion of the C BLEED HOT caution ICAW. (Tab EE)**

At 19:42:18L the fire protection system (FPS) detected a bleed air leak in the center bleed air ducting from both engines. In response to the FPS, the Integrated Vehicle Subsystem Controller (IVSC) asserted the C BLEED HOT caution ICAW while it requested the Environment Control System (ECS) to isolate the center bleed system. “CAUT” was displayed in the heads up display (HUD) advising the MP of the caution ICAW. (Tab J-4) When the C BLEED HOT caution ICAW asserted, the following functions were lost:

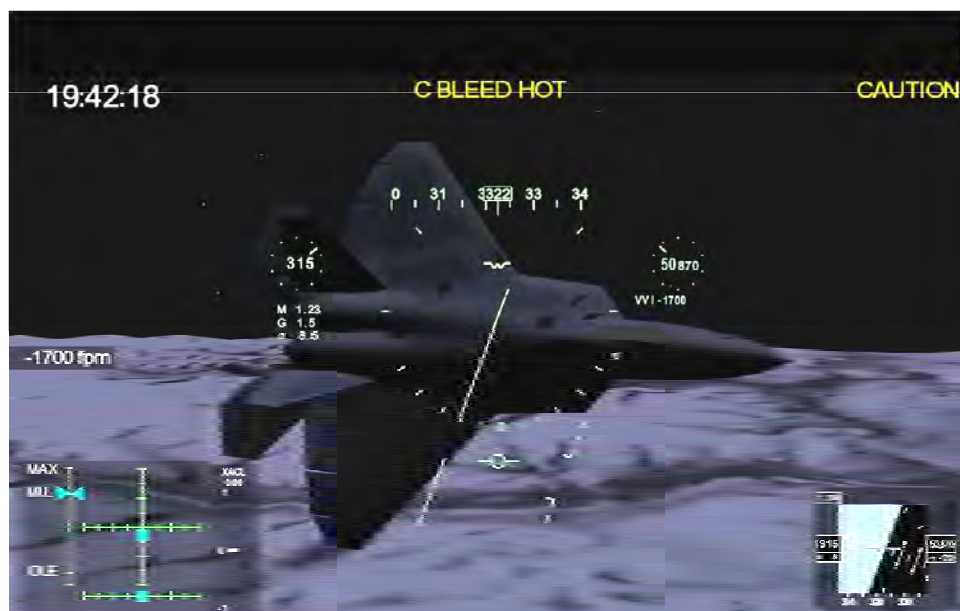
The MA was at 50,870 ft MSL, 315 knots calibrated airspeed (KCAS), 1.23 M, with an attitude of 1 degree nose up, 69 degrees right wing down (RWD), heading 323 degrees, 1.5 g, and with a vertical velocity indication (VVI) of -1,700 ft per minute (fpm). (Tab EE)

**Figure 2 19:42:18 -- MA parameters at assertion of C BLEED HOT caution ICAW. (Tab EE) See Tab Z-10 for a diagram explaining the symbology in the Figures.**

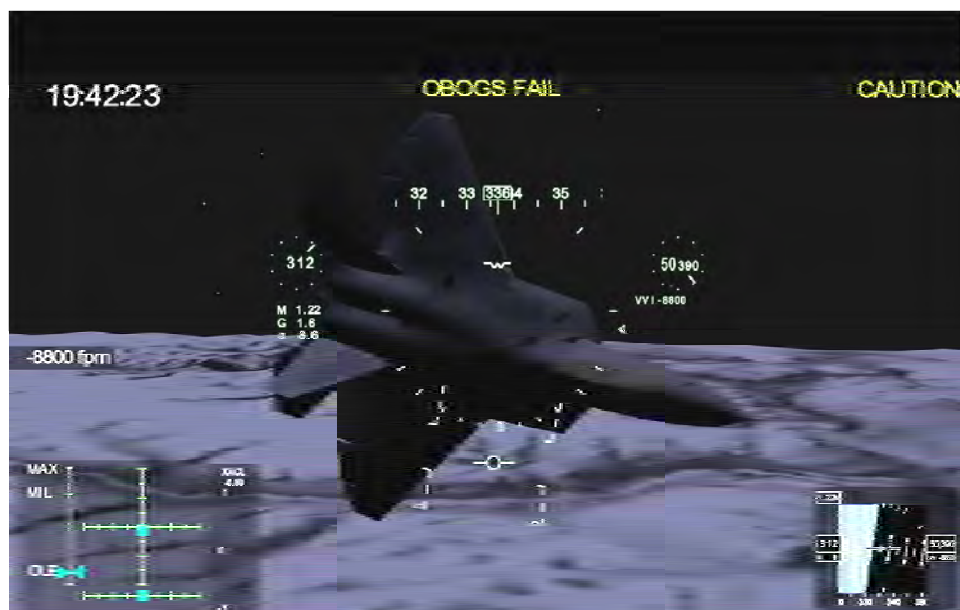
**Figure 3 19:42:23 – MA parameters at assertion of OBOGS FAIL caution ICAW. (Tab EE)**

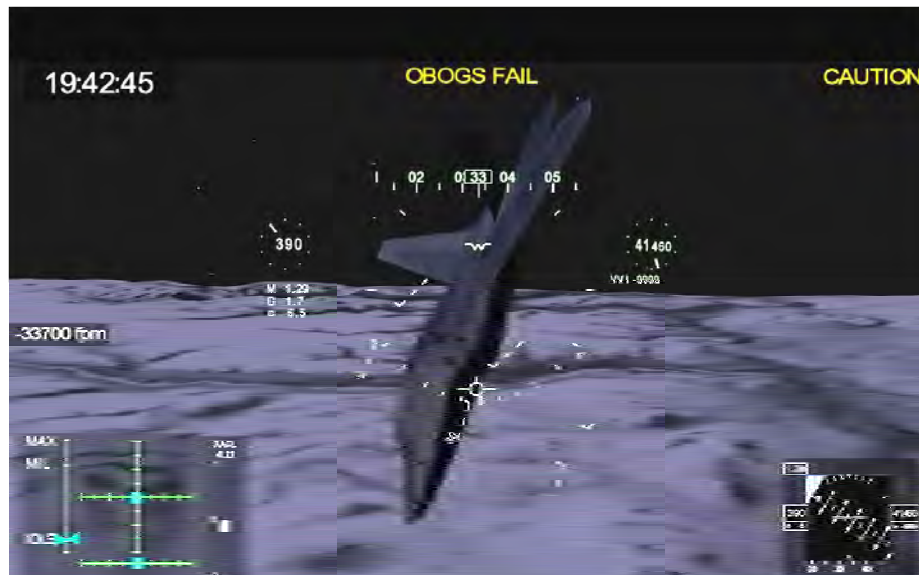
At the assertion of this ICAW until 19:42:45L, the MP retarded the throttles to IDLE power and deliberately continued a controlled, descending right hand turn to descend to a lower altitude IAW the checklist. (Tab BB-29) At this time the MA was at 41,460 ft MSL, 390 KCAS, 1.29M, 30 degrees ND, 44 degrees RWD, 1.7 g, and with a VVI of -33,700 fpm. (Tab EE)

**Figure 4 19:42:45 – MP deliberately flew to a controlled attitude of 30 degrees ND and 44 degrees RWD in order to descend to a lower altitude IAW the checklist. (Tab EE)**

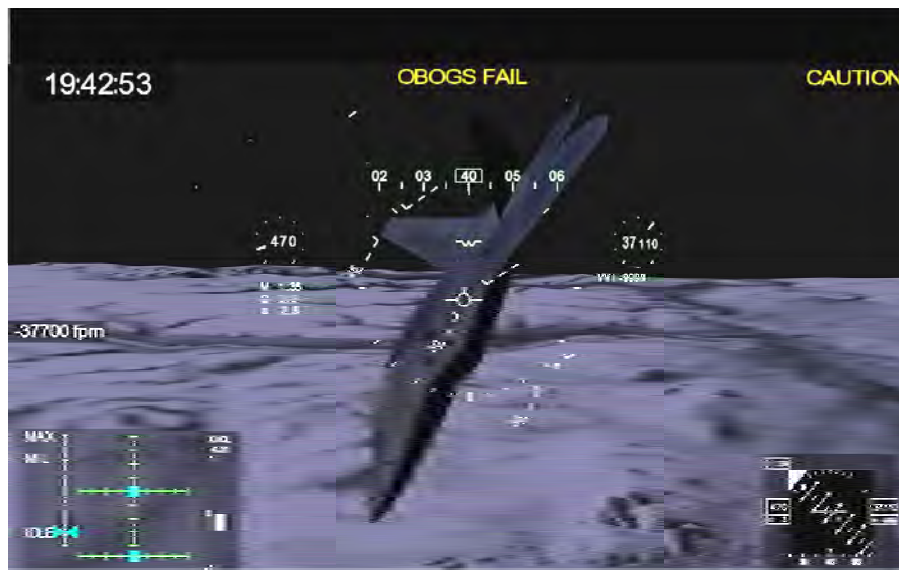
The CSMU mishap data discrete signal showed partial pressure to the MP's oxygen mask stopped shortly after 19:42:37L, which would lead to severely restricted breathing. (Tab J-43) From 19:42:45L until 19:42:53L, the MP made no inputs to the stick, pedals, or throttles, and the MA maintained a relatively stable bank angle and attitude. The MA was at 37,110 ft MSL, 470 KCAS, 1.35M, 30 degrees ND, 46 degrees RWD, 0.8 g, with a VVI of -37,700 fpm. (Tab EE)

**Figure 5 19:42:53 – MA parameters after 8 seconds of zero MP inputs to stick, pedals, or throttles. (Tab EE)**

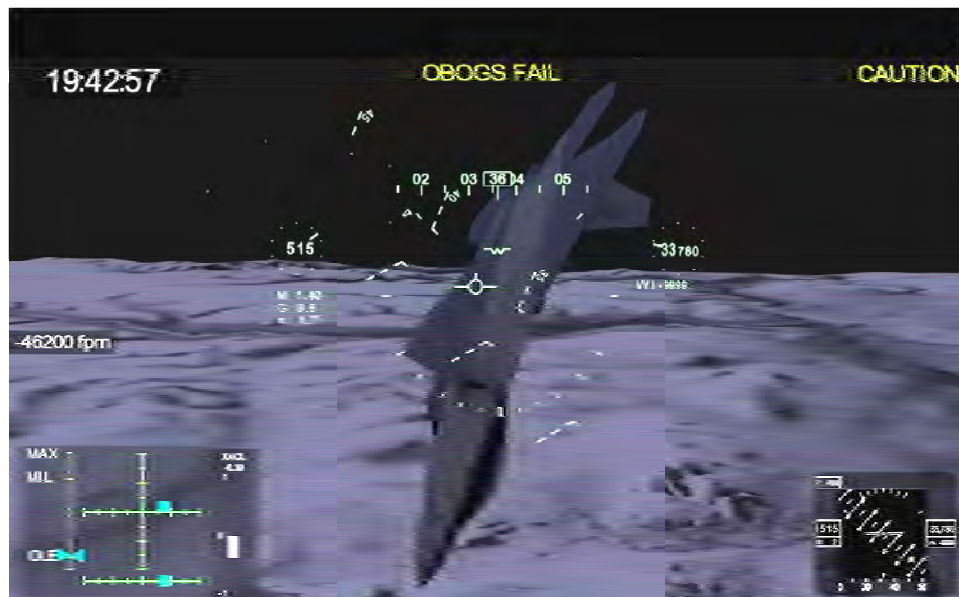
At 19:42:53L, the MP input a combination of right forward stick and right pedal which initiated a 240 degree descending right roll at greater than 45 degrees per second. (Tab EE)

**Figure 6 19:42:57 – MA parameters during MA 240 degree roll to the right resulting from stick and pedal inputs. (Tab EE)**

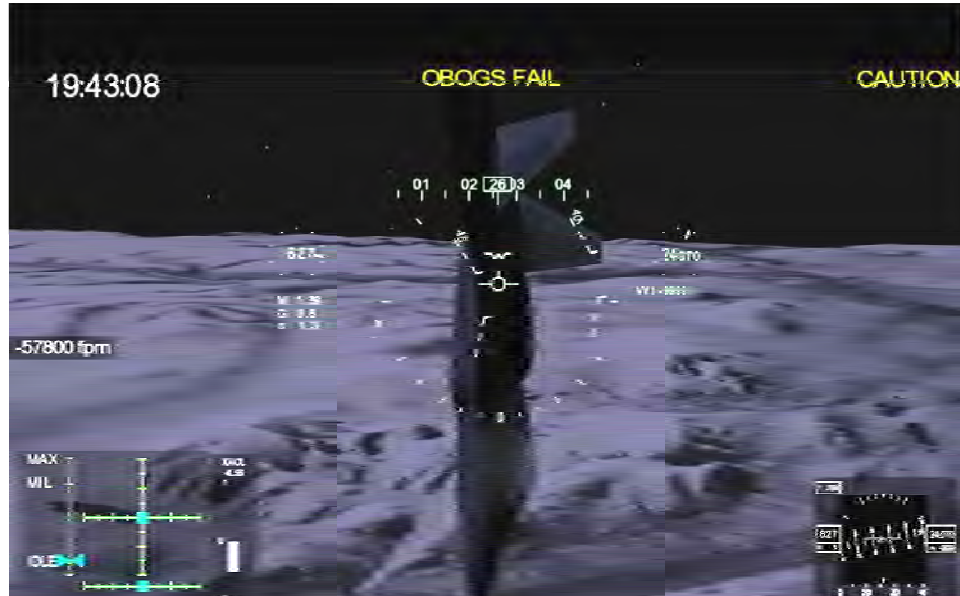
At the completion of these stick and pedal inputs at 19:43:08L, the MA had rolled through inverted, experienced less than 1 g of gravitational force, and went from a RWD to Left Wing Down (LWD) attitude, and the descent rate of the aircraft significantly increased. The parameters at this time were 24,070 ft MSL, 627 KCAS, 1.39M, 44 degrees ND, 81 degrees LWD, 0.8 g, with a VVI of -57,800 fpm. (Tab EE)

Figure 7 19:43:08 – MA parameters when stick and pedal inputs cease after the 240 degree roll. (Tab EE)

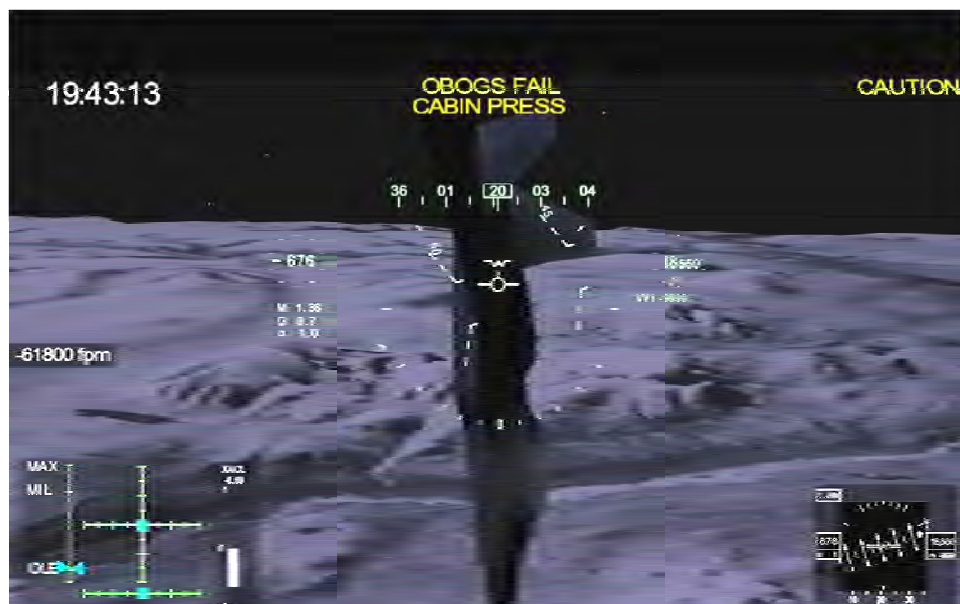
After 19:43:08L, there were no stick inputs and only very minor pedal inputs for the next 15 seconds. At 19:43:13L, passing approximately 19,000 ft MSL, a CABIN PRESSURE caution ICAW asserted based on cockpit pressurization exceeding its normal schedule. (Tab J-13)

Figure 8 19:43:13 – MA parameters at assertion of CABIN PRESS caution ICAW. No stick or pedal inputs. (Tab EE)

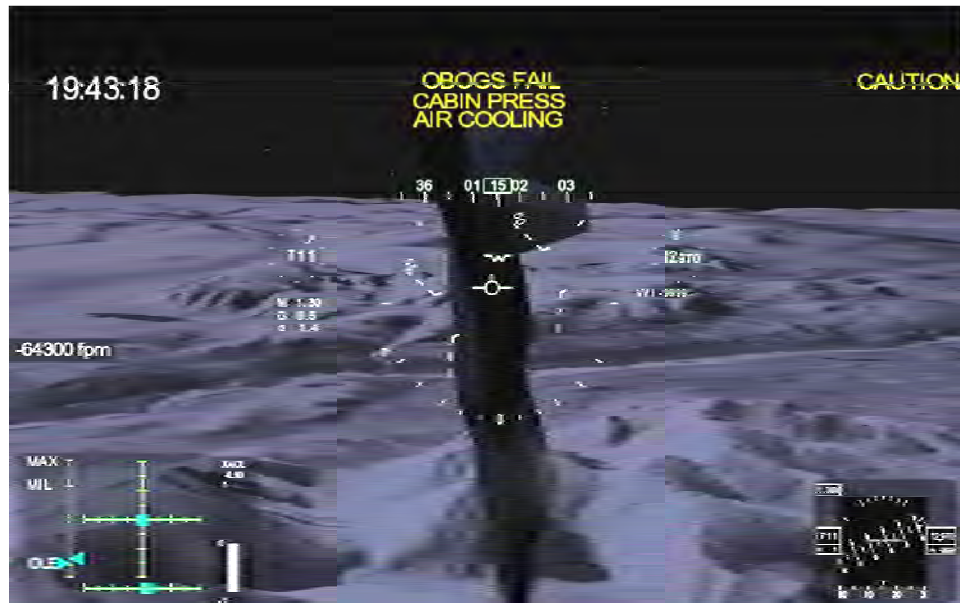
At 19:43:18L, passing 12,400 ft MSL, an AIR COOLING caution ICAW asserted. This ICAW would assert 60 seconds after a C BLEED HOT caution ICAW if the aircraft were not receiving an adequate cooling air source to its avionics. (Tab J-13)

**Figure 9 19:42:18 – MA parameters at assertion of AIR COOLING caution ICAW. No stick or pedal inputs. (Tab EE)**

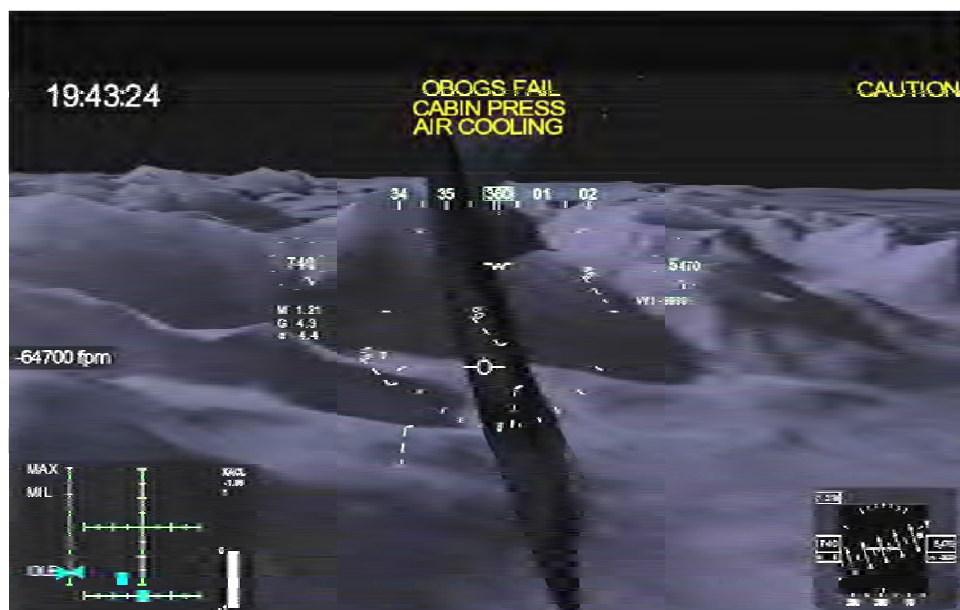
At 19:43:24L the MP performed a dive recovery at 5,470 ft MSL by pulling aft on the stick, producing a 7.4 g pull up maneuver. The MA impacted the ground 3 seconds later, inflicting fatal injuries to the MP and destroying the MA. (Tab EE)

**Figure 10 19:43:24 – MP initiates full aft stick pull to start dive recovery at 5,470 ft MSL. (Tab EE)**

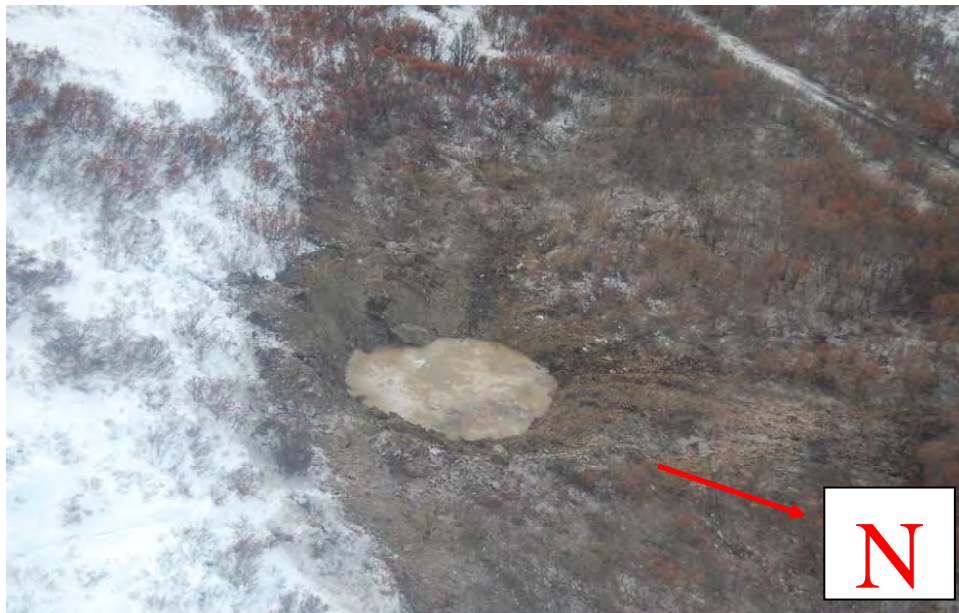
At 19:43:27L, the MA impacted the ground at 735 KCAS, 1.17M, 48 degrees ND, 47 degrees LWD, 7.4 g, with a VVI of -57,900 fpm. The impact site is approximately 120 NM north of JBER, AK, in the Talkeetna Mountain range. The site is approximately 3,100 ft MSL near the edge of a south-west to north-east running valley. The impact crater is located at the valley floor where it begins to slope upwards towards the southeast. The valley floor is approximately one-half mile wide at this point and has a stream running through it approximately 60 yards west of the impact point. (Tabs J-4 through J-6)

The debris field consisted of small aircraft and engine pieces extending approximately one-quarter mile from the crater. The upslope wall of the crater and aircraft impact angle appear to have focused the debris pattern in a 60 – 80 degree wide arc from west to north. (Tabs J-4 through J-6)

**Figure 11 Impact Crater 17 Nov 2010 (Tab S-7)**

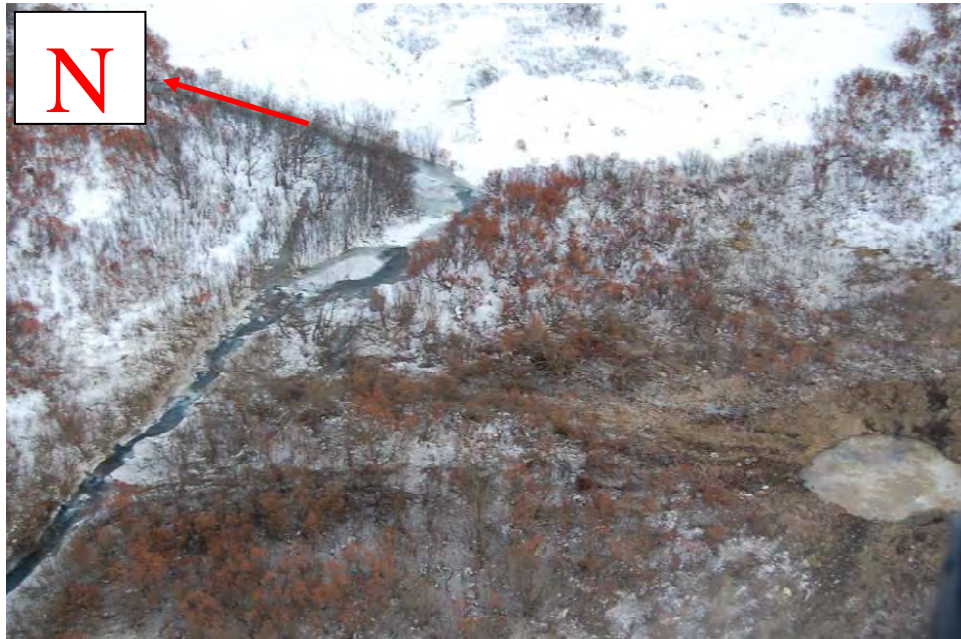
**Figure 12 Impact Site. 17 Nov 2010 (Tab S-7)**

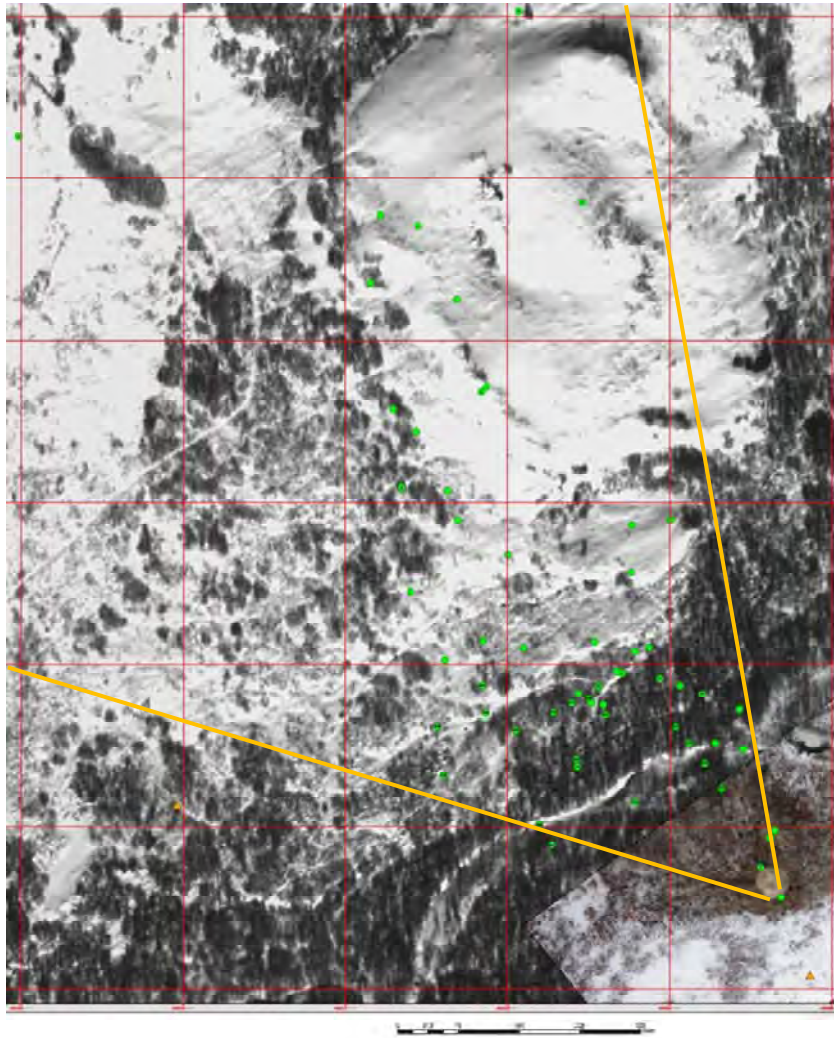
**Figure 13 Aircraft Parts Scatter Diagram. Parts represented by green dots. (Tab S-4)**

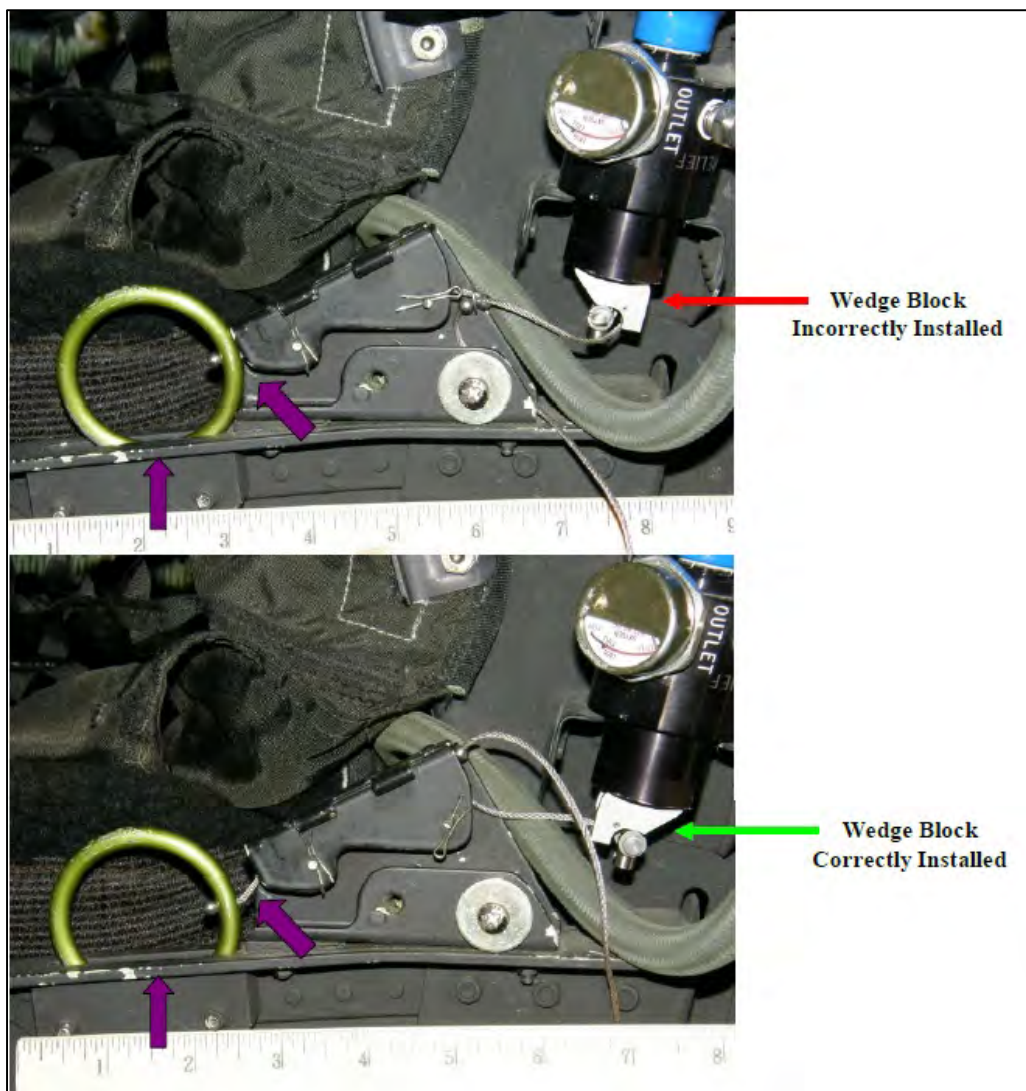
The AFRL report identified that if the EOS wedge block had been incorrectly installed, the wedge block would be unable to move or rotate during manual EOS ring activation. However, during ground simulation the board members were able to initiate the EOS in the incorrectly installed position. (Tab U-4)

**Figure 14- The wedge block installed incorrectly (red arrow) and correctly (green arrow). Notice the position of the ring within the seat (purple arrows) based on wedge block position. (Tab Z-6)**

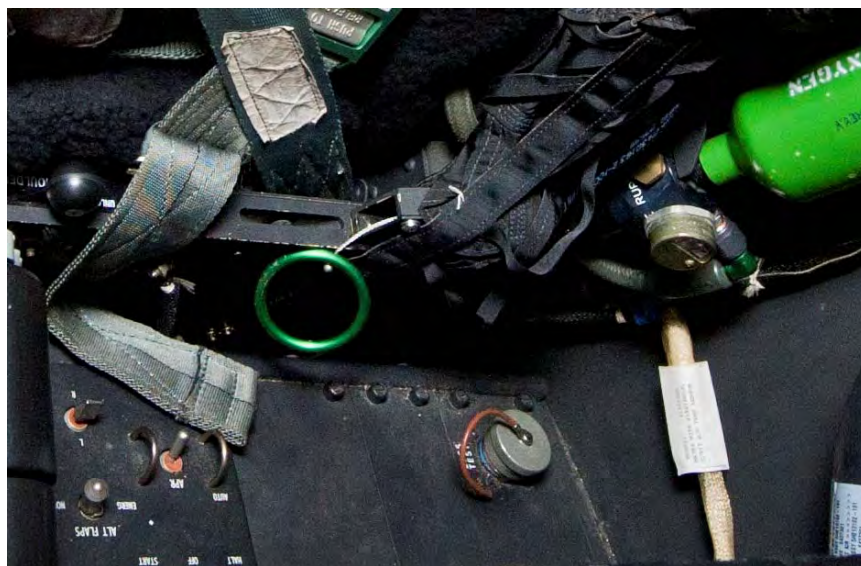
During ground simulation, the manual EOS activation ring was unseated and dropped between the seat and console prior to EOS activation. This was done to simulate a failed initial pull,

**Figure 16- Manual EOS activation ring fallen below lip of seat. (Tab CC-5 and Tab Z-8)**

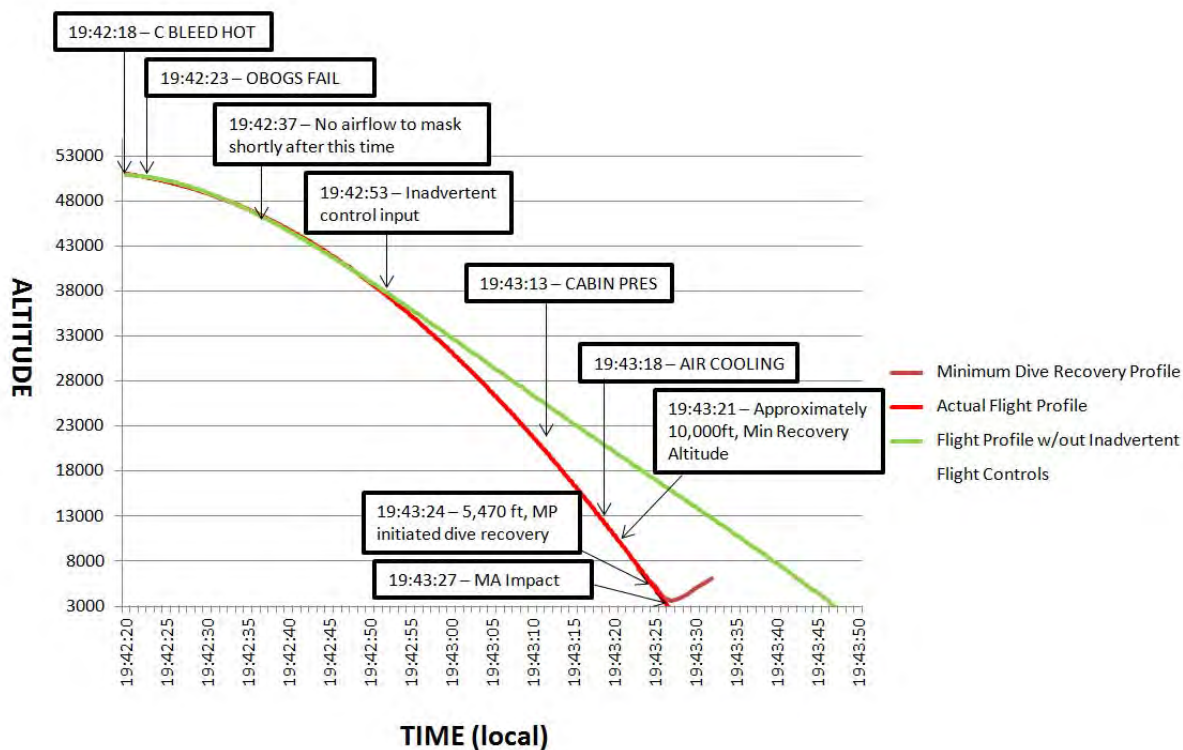
Fifth, the MP was late to recognize the necessity for a dive recovery. At 19:43:27L, the MP impacted the ground because his channelized attention and breakdown in visual scan resulted in unrecognized spatial disorientation. When the MP recognized the MA attitude and altitude, he was below minimum recovery altitude. Figure 17 shows the actual initiation of the attempted dive recovery altitude along with the 1F-22A-1 minimum recovery altitude.

**Figure 17 Flight profiles for MS. Actual flight profile (red), flight profile without inadvertent flight control inputs (green), and minimum altitude dive recovery profile (maroon) shown.**
